Home Energy Assessment Report

01/20/2015 An Evaluation of Your Home's Energy Efficiency

Property Address: 5648 La Casa Way, Sacramento, CA 95835

Property Type: Single family, two story 4 bedrooms with attic and slab

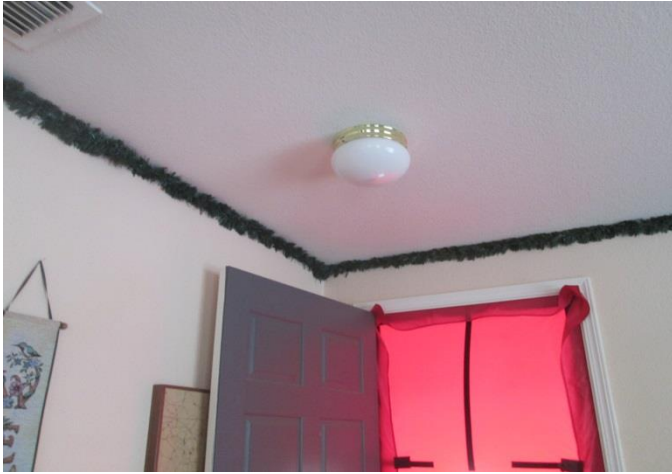
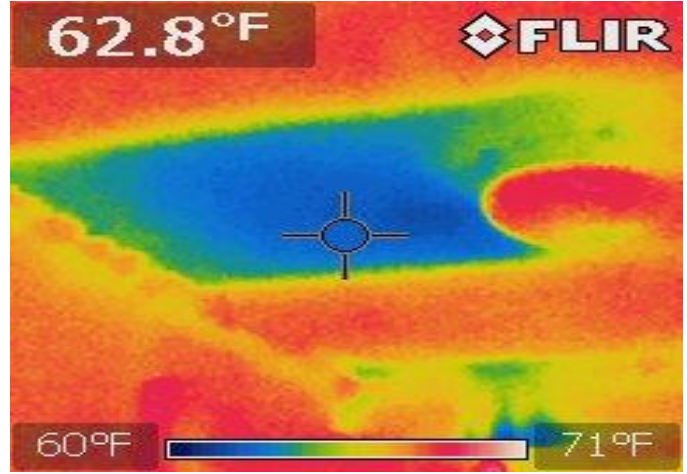
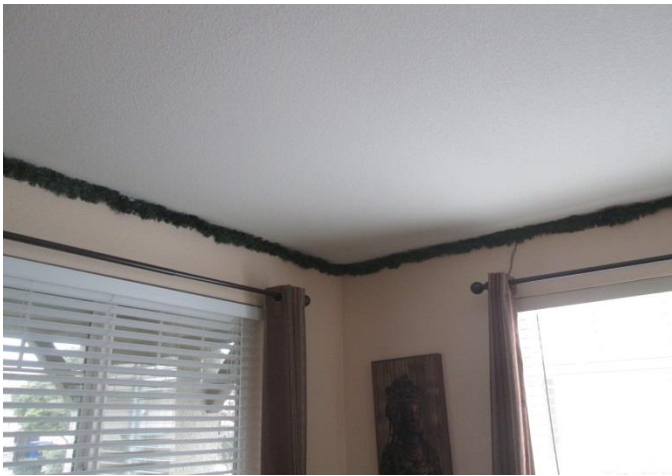
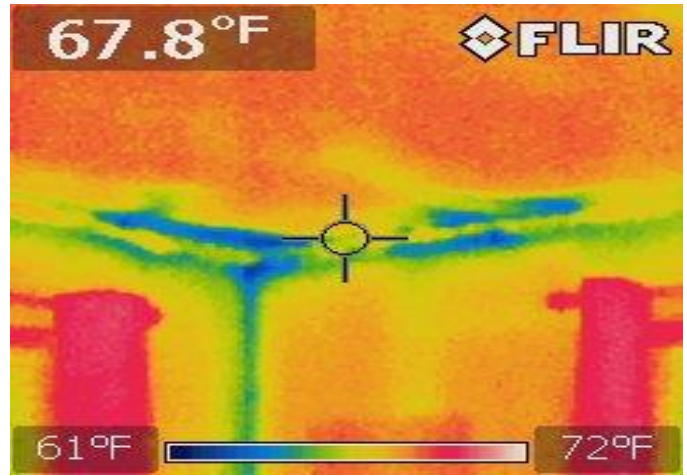
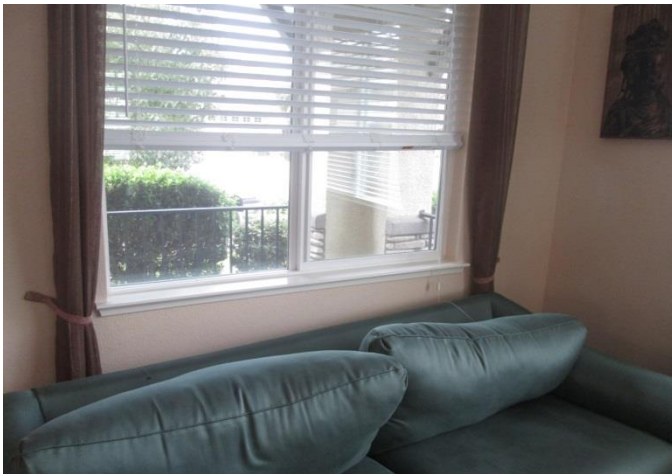
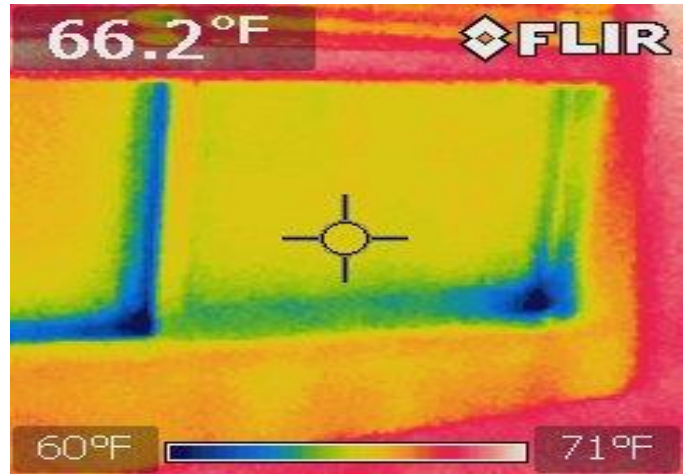
Photography

These photos are representatives of what we saw with the infrared camera and what we saw with the digital camera of the same area while the house was being depressurized. It depicts where the air leakage is and where the heat and cold transfers exists. Heat and cold transfers is that area where the outside air penetrates into the home. Dark blue means a lot of air movement. The red and orange is heat coming through the leaks in the ceiling and crawlspace.
